STATUE OF LIBERTY NATIONAL MONUMENT EMPLOYEE  
HOUSING, TRIPLEX  
(Statue of Liberty National Monument, Building No. 44A-C)  
Statue of Liberty National Monument  
Liberty Island

HABS NY-6397-C  
*HABS NY-6397-C*

### STATUE OF LIBERTY NATIONAL MONUMENT EMPLOYEE HOUSING, TRIPLEX (Statue of Liberty National Monument, Building No. 44A-C)

HABS No. NY-6397-C

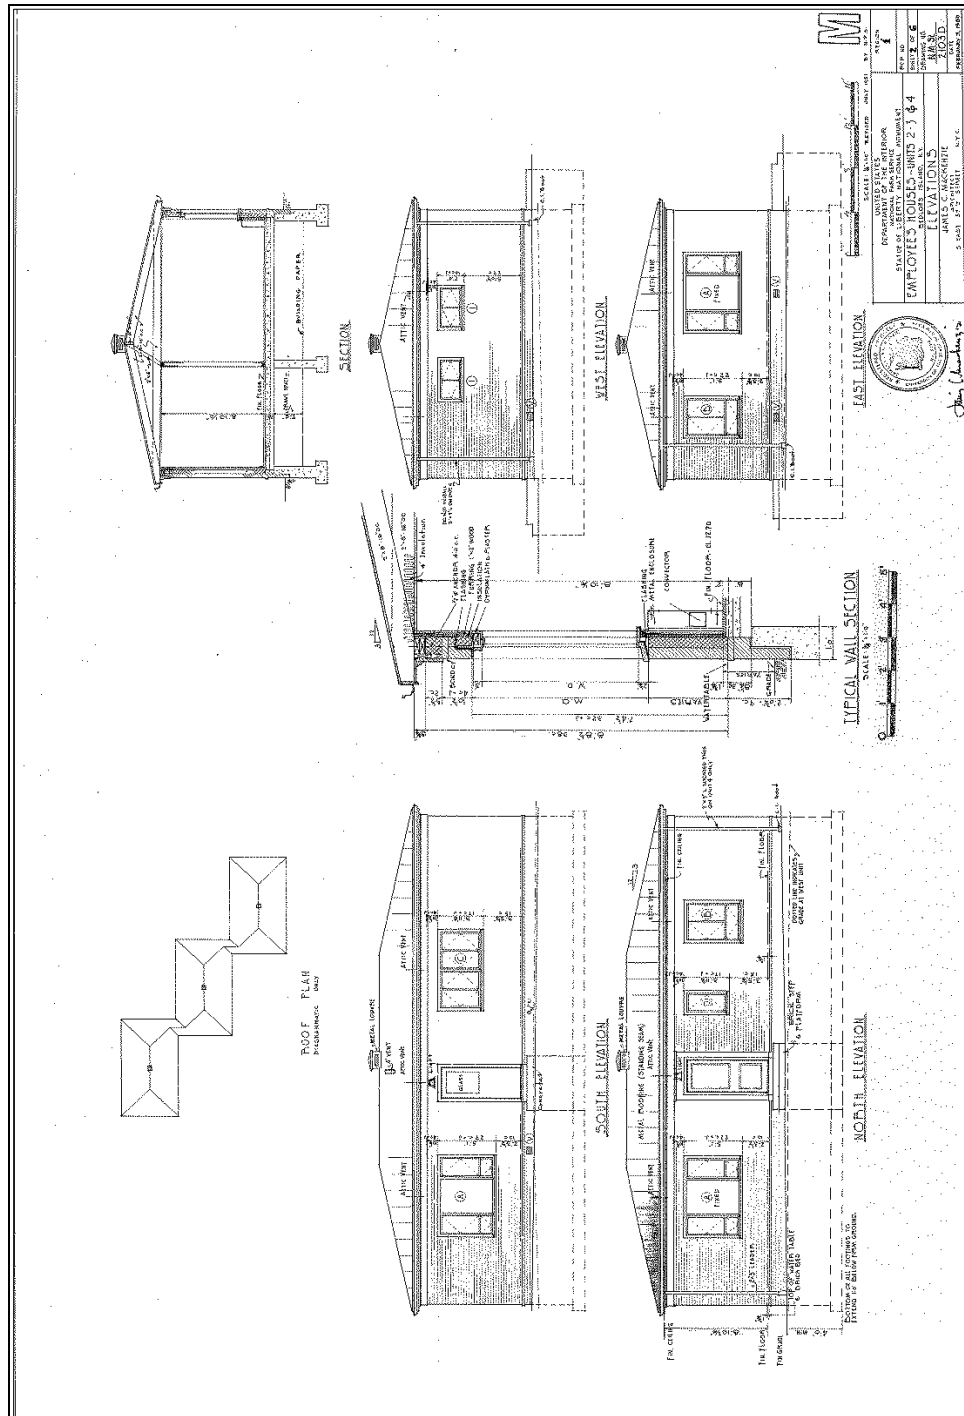
Figure 1: Elevations and section, Triplex, February 3, 1950.

Note the diagram of the roof plan showing the stepped arrangement of the Triplex units.

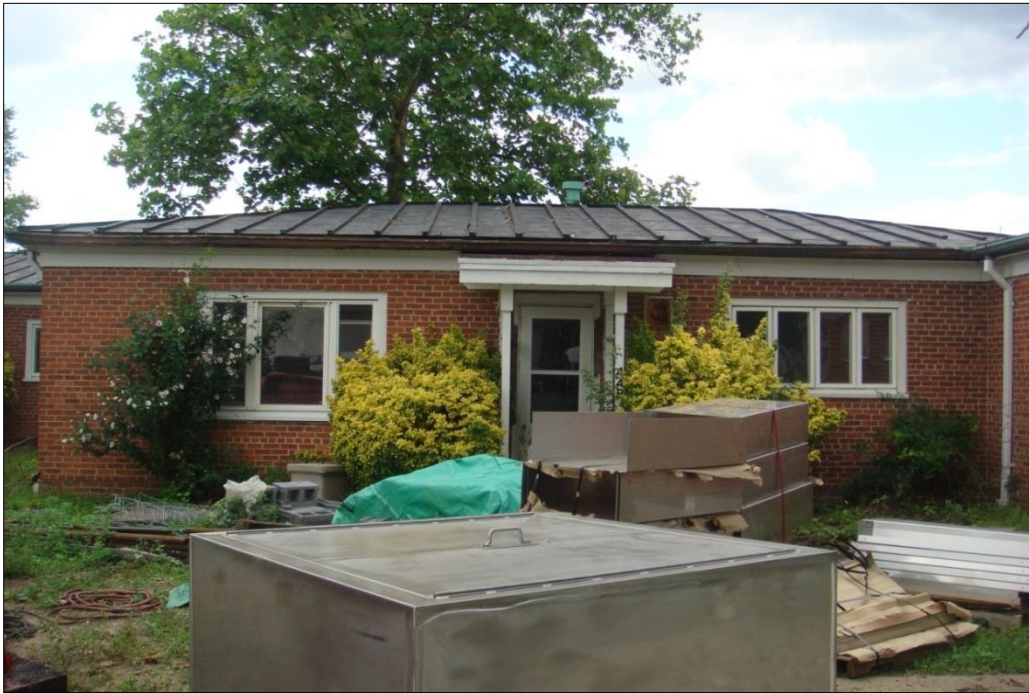
corners, where they have been arranged in a stepped manner such that seven feet of wall and roofing overlaps with each successive unit at the corner (Figures 3 and 4).

Figure 3: Triples, Unit 44B south elevation (rear entryway), July 16, 2014.  
Note the symmetrical, three-bay arrangement with a central entryway and the corner connection to the other units.  
Source: Photograph by author.

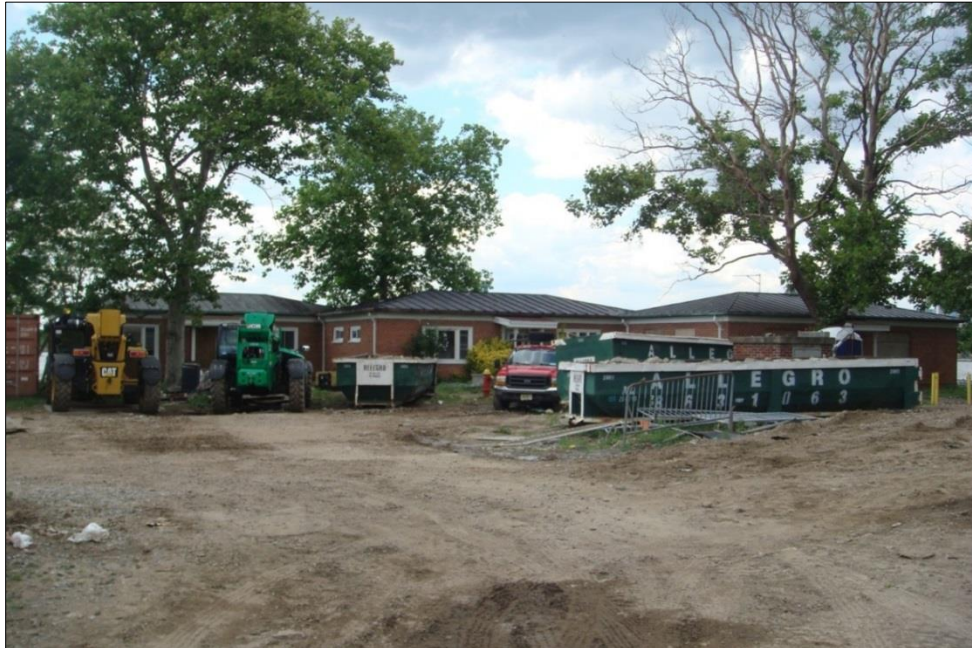
Figure 4: Triples, west and south elevations through the cluttered courtyard, July 16, 2014.  
Source: Photograph by author.

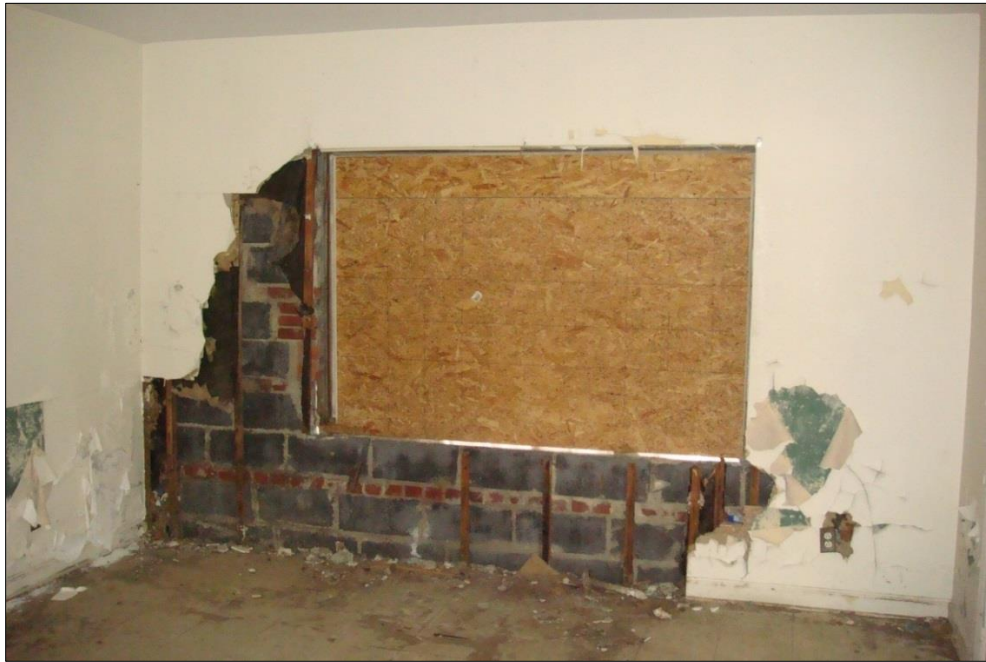
The load-bearing walls are executed in a hollow concrete block and brick wall system (with a course ratio 2:1) with an exterior brick veneer finish (Figure 5). The concrete blocks measure one foot, 5 1/2 inches by 7 1/2 inches and are 3 3/4 inches wide with three hollow cells while the bricks measure from 7 1/2 to 7 3/4 inches by 2 1/4 inches and are 3 3/8 inches wide. Southern pine wood framing (either dip-treated or painted with creosote) and light gauge steel members form the interior walls and framing.<sup>7</sup>

Figure 5: Triples, Unit 44B's interior living room wall: facing east, July 16, 2014.  
Note the revealed hollow concrete block and brick load-bearing exterior wall.  
Source: Photograph by author.

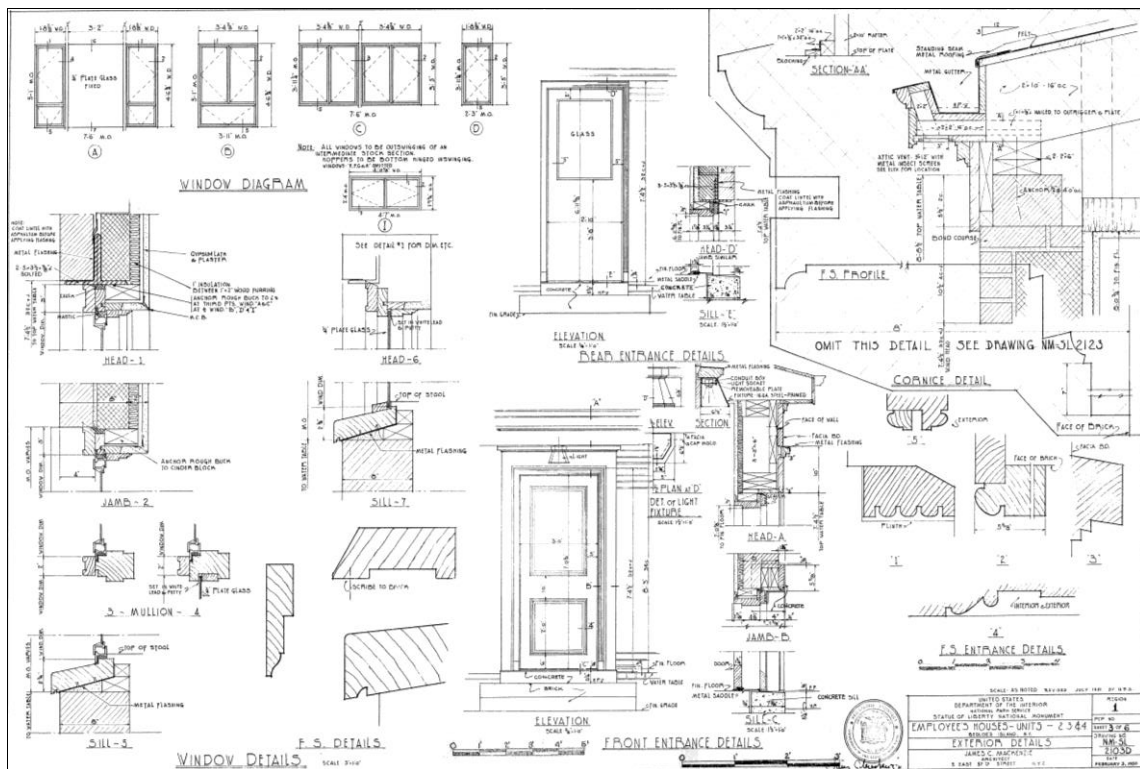
- b. Windows: The Triplex has several different sized window openings, which are now filled with replacement sash (c. 1990s) or more commonly, plywood covering. The original architectural drawings indicate that each Triplex unit had three picture windows flanked by combination casement and hopper opening side lights (Figure 6). These large window openings were located at

Figure 6: Exterior Details, Triples (Units 2, 3, & 4), February 3, 1950.  
Source: Electronic Technical Information Center (eTIC), Denver Service Center, National Park Service.

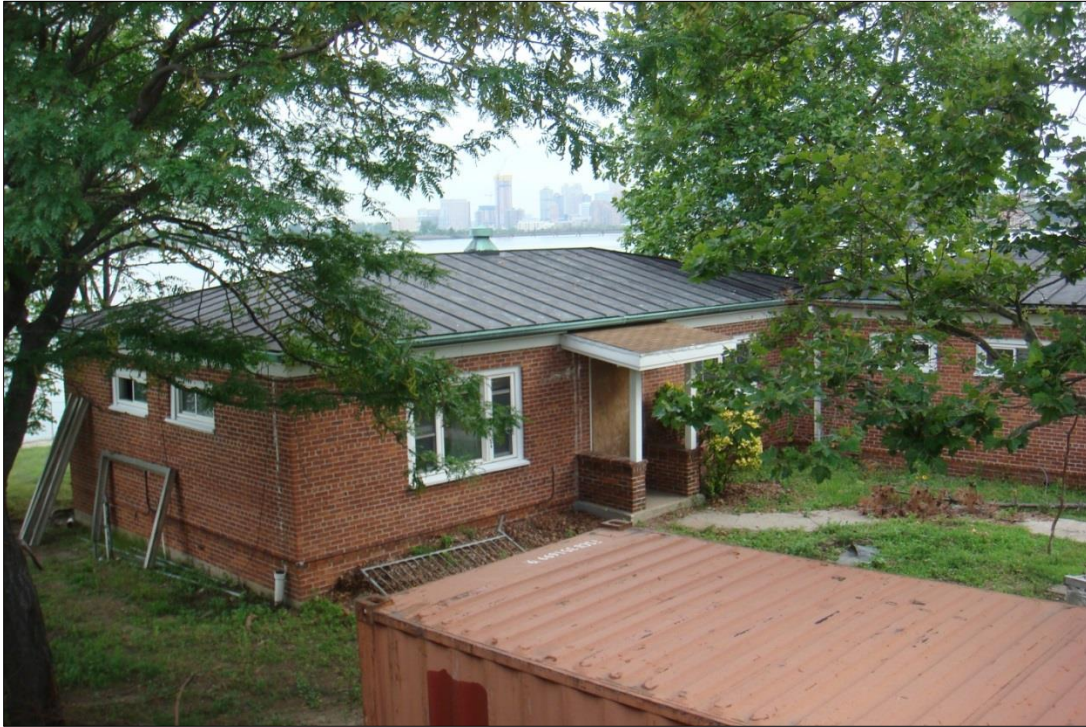
- a. Shape, covering: Each unit of the Triplex has a nearly independent standing seam, metal hipped roof with a shallow 3:12 pitch. The standing seams on Unit 44B are thicker than those on the other two units suggesting its later replacement (Figure 7).
- b. Cornice, eaves: The Triplex a simple eight-inch white fascia board covering the attic vent with a two-inch trim cornice molding abutting the white vinyl soffit, which overhangs about four inches. The house has external copper gutters with a green patina and white vinyl downspouts: most of which are missing but the clips and outlines remain (Figure 8).
- c. Roof projections: There are two TV antennae (one on Unit 44A and one on Unit 44C) on the Triplex roof. Each unit's roof has a stout cylindrical ventilator and a narrow pipe vent both with a green patina.

Figure 7: Triplex, view down from the second story of the Duplex toward Unit 44C, July 16, 2014.  
Note the simple standing seam, metal hipped roof and external copper gutters with a green patina.  
Source: Photograph by author.

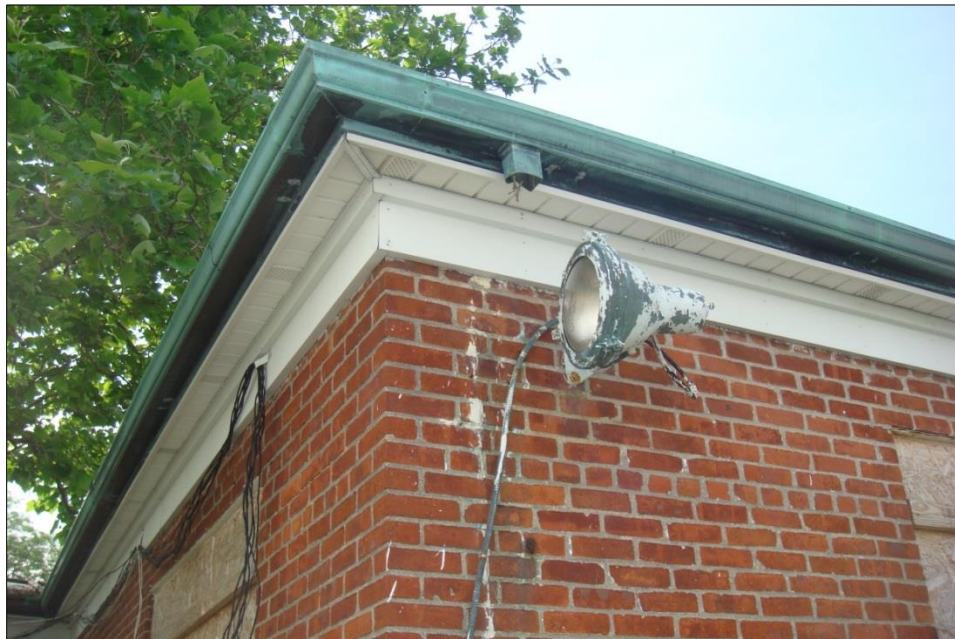
Figure 8: Triplex, Unit 44C's northeast corner, cornice detail, June 18, 2014.  
Source: Photograph by author.

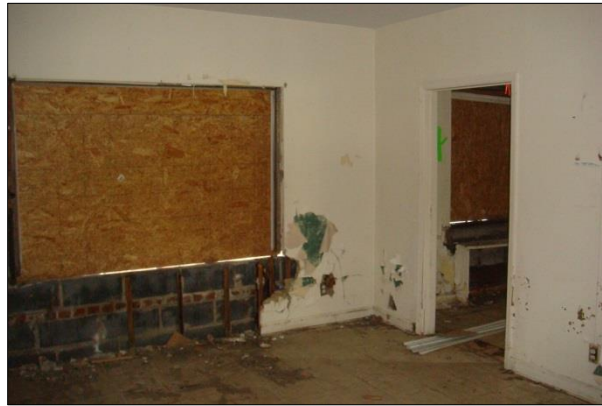
Figure 9: Triplex, facing southeast inside the living room of Unit 44B, July 16, 2014. Note the passage to the dinette.  
Source: Photograph by author.

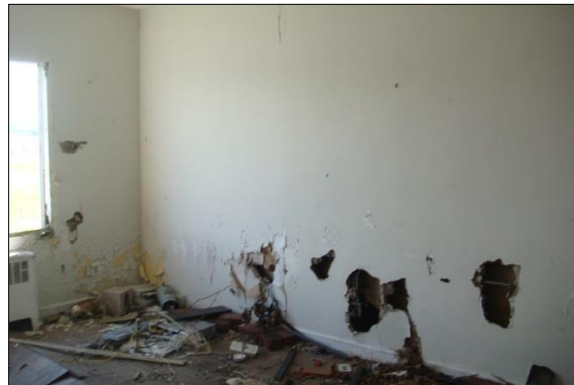
Figure 10: Triplex, facing southeast inside the living room of Unit 44A, June 18, 2014.  
Note the continuation of the wall instead of a passage to the dinette.  
Source: Photograph by author.

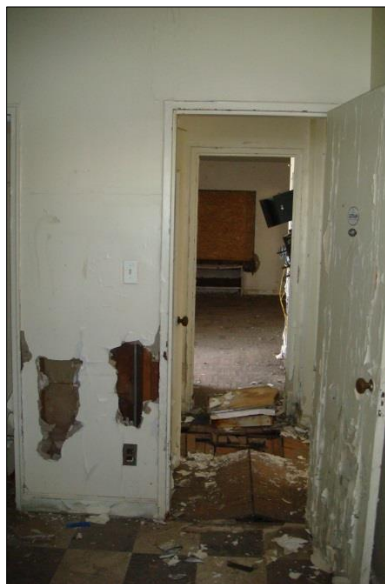
2. Stairways: None.
3. Flooring: The Triplex has a variety of coverings over a concrete subfloor. The living rooms, both Unit 44A bedrooms, and one Unit 44C bedroom have wood parquet flooring arranged in alternating nine-inch squares. The other bedroom in Unit 44C has nine-inch square black and white linoleum flooring. The bedrooms in Unit 44B have nine-inch square brown vinyl tiles (Figure 11).

Figure 11: Triplex, view from Unit 44C's northwest corner bedroom looking through the corridor into the living room, June 18, 2014. Note the extensive flood damage to the parquet flooring, walls, and doors.  
Source: Photograph by author.

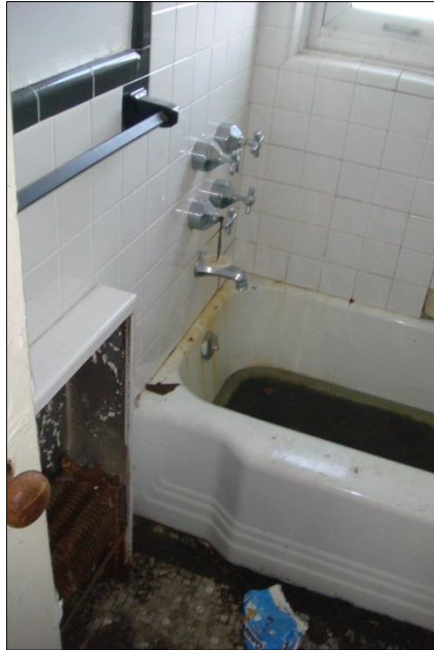
All kitchens have five-inch square white ceramic tiles as do the bathrooms in Unit 44A and Unit 44B. The bathroom in Unit 44C has one-inch square ceramic mosaic tile that appears to be original and matches the bathroom floors in the Duplex. The ceramic tiles are in a pattern of gray squares with a white square tile at the center. Each bathroom floor includes a five-inch wide border of black one-inch square mosaic tiles (Figures 12 and 13). The dinette areas in Unit 44B and Unit 44C have nine-inch square gray vinyl tiles.

Figure 12: Triples, Unit 44C's bathroom, June 18, 2014.  
Note the original tile flooring, tile wainscot, bathtub, and cross-bar valves.  
Source: Photograph by author.

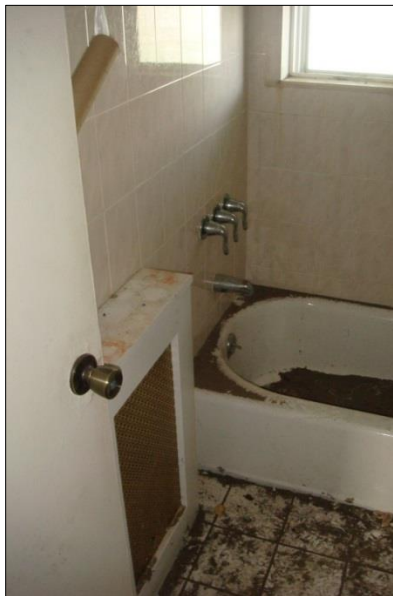
Figure 13: Triples, Unit 44B's bathroom, July 16, 2014.  
Note the newer tile floors, walls, and fixtures compared to above.  
Source: Photograph by author.

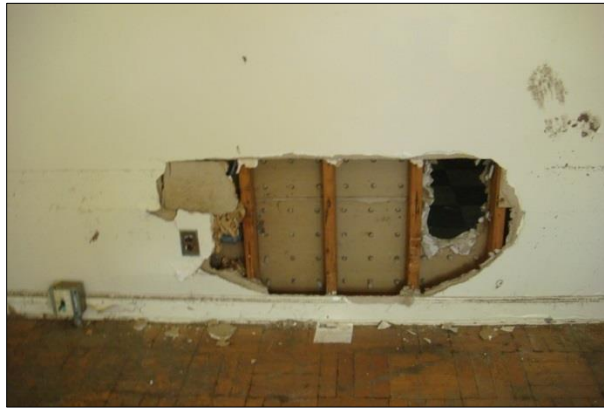
4. Wall and ceiling finish: According to the architectural drawings, the walls and ceilings were intended to be covered with gypsum plaster on lath. However unlike traditional gypsum plaster on lath where the lath is either a wood or metal material, the plaster is applied to wallboard. With storm damage revealing the interior of walls, one finds patent no. 2,442,321 used by Newark Plaster in South Kearny, New Jersey on the wallboard, which has with circular perforated holes covered by a thick plaster layer (Figure 14). There is metal lath behind the ceramic bathroom tiles as well as around corners and window openings.

Figure 14: Triples, Unit 44A's living room wall facing south, June 18, 2014.  
Note the plaster-on-perforated-wallboard construction and the parquet flooring.  
Source: Photograph by author.

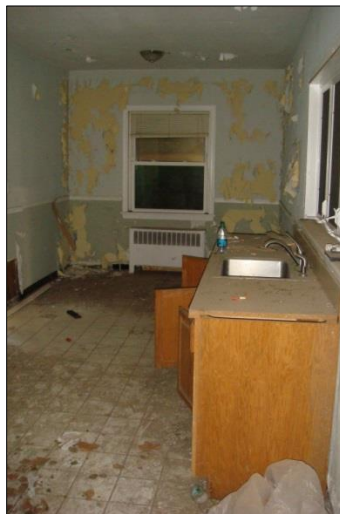
The kitchen in Unit 44C has a five-inch wide floral pattern band of wallpaper that runs along the top wall about five inches down from the ceiling. The kitchen in Unit 44B is unadorned and painted white. The kitchen in Unit 44A has a chair rail about forty-two inches up the wall that was a later alteration (Figure 15). All walls (except for in the tiled bathrooms) have a white baseboard with a toe molding and an ovolo molding above.

Figure 15: Triples, Unit 44A's kitchen facing east, June 18, 2014.  
Source: Photograph by author.

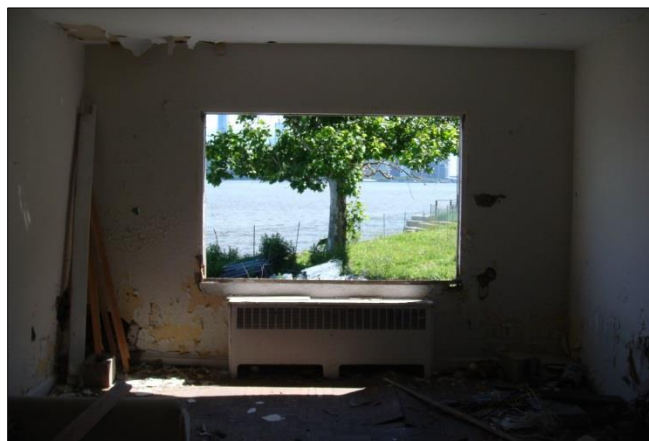
8. Mechanical equipment:
  - a. Heating, air conditioning, ventilation: Most of the window openings in the Triplex (except for those in the kitchens and bathrooms) had a partially recessed radiator beneath. These radiant heaters have dense fins—hot water heating coils—that are encased in perforated, metal covers (Figure 16). The hot water for radiant heat was provided by the nearby central boiler plant.

Figure 16: Triples, Unit 44A's living room facing east, June 18, 2014.  
Note the radiator below the window and the view of the Manhattan skyline.  
Source: Photograph by author.
